Exogenic Hazards in Amirsoy Resort Area: Analysis and Mountain Slope Impact

Exogenic Hazards in Amirsoy Resort Area: Analysis and Mountain Slope Impact.

In *Proceedings of the 2nd Pamir Transboundary Conference for Sustainable Societies (PAMIR-2 2023)*, pages 1564-1570

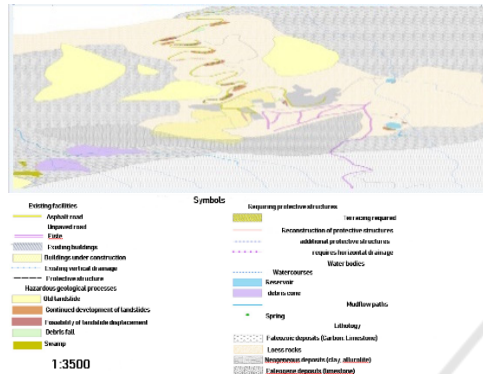
landslides. Furthermore, seven extensive prehistoric landslides were found in the resort's northern regions. In the 2017–2018 survey, 22 historical and contemporary landslides were found. In September 2021, when we conducted our investigation, we found that the landslide was still occurring in some of the areas, that there was one large-scale landslide (located at 41 ° 29'52.95 "N, 69 ° 56'11.84 "E), and that there were other little landslides (approximately ten locations showed evidence of sliding) (Figure 5).

Figure 5: Hazardous exogenic processes' distribution map in the Amirsoy resort region.

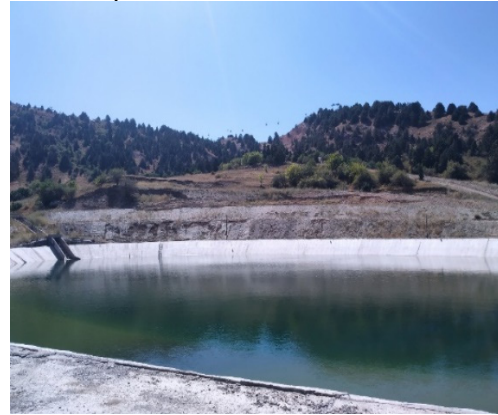
Groundwater is primarily responsible for the "decline" in the stability of the distributed rocks and the production of landslides, according to an analysis of the geological and hydrogeological parameters of the Amirsoy resort area. Furthermore, there is a risk of debris fall since the slope is made up of proluvial (rock, debris, and clay) rocks that have been cut for road building, which has decreased the strength of the rocks and increased the slope's gradient (Fig. 6). The stones are tiny, but if they fall on a roadway, they might pose issues for passing cars.

Figure 6: A reservoir to collect mudflow water.

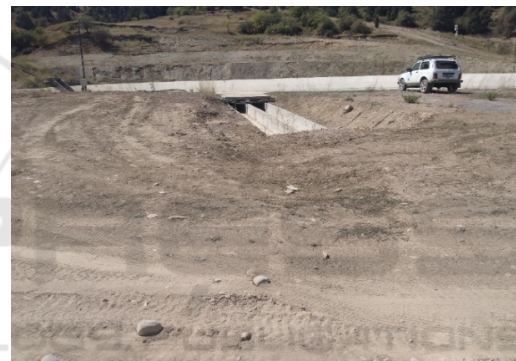
Additionally, mudflow channels surrounding the Amirsoy resort region were examined. The slope is steep and the upper portion accumulates a lot of snow; mudflows from snowmelt during the precipitation season (late March to early May) did not negatively affect the resort area. A reservoir for collecting mudflow water and an extra drainage route were constructed at the intersection of multiple mudflow channels (sais). By taking this action, the chance of mudflows will be decreased and a summertime water supply will be increased (Figure 7).

Figure 7: A reservoir to collect mudflow water.
