Superpixel-wise Assessment of Building Damage from Aerial Images

Lukas Lucks, Dimitri Bulatov, Ulrich Thönnessen and Melanie Böge

*Fraunhofer Institute of Optronics, System Technologies and Image Exploitation
Gutleuthausstr. 1, 76275 Ettlingen, Germany*

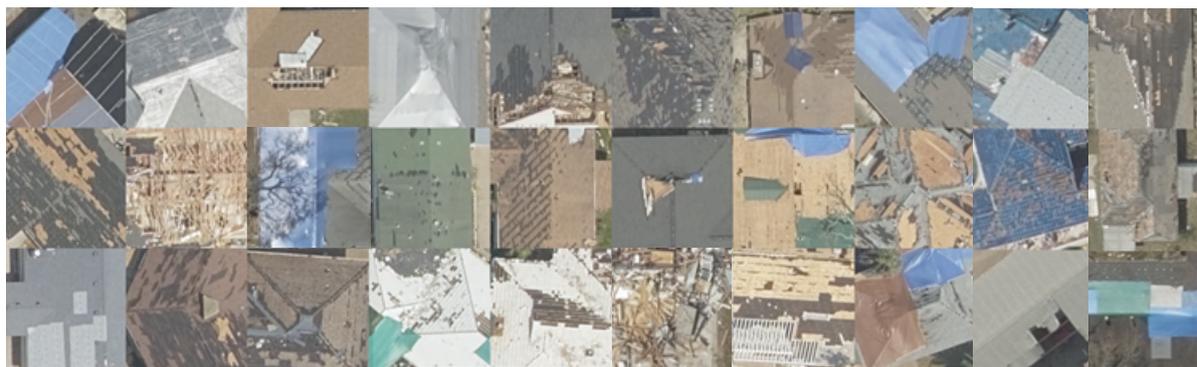
Figure 2: High-resolution images showing different types of damage.

The selection of training data is an essential step for reliable classification. Hence, it is important to include appropriate representatives of as many situations as possible in the training set, including different types of damage, such as blown-away shingles and broken roofs, as well as different types of undamaged roofs, such as solar panels, areas of sound roof material, intact pools, air conditioners, and other superstructures (as illustrated in Fig. 2). The occlusion of roofs by trees is an ambiguous problem as it can range from branches covering the view of the roof or small branches scattered on the roof causing no damage to uprooted trees fallen on the roof and causing significant damage. As in other cases of ambiguity, by way of precaution, it was decided to classify all regions covered by trees as damaged.

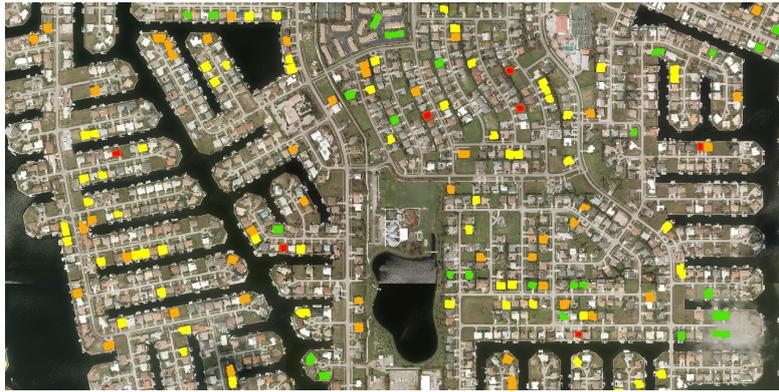
Figure 3: Visualization of damaged buildings on a map. Buildings in the portfolio are colored according to the damage ratio (green: intact, yellow: light damage, orange: medium damage, and red: heavy damage).

amaged roof. Thus, it is possible to determine the ratio between the total number of pixels in damaged superpixels and the number of pixels assigned to the roof area, which reflects the damage grade of the building. Depending on the task or for map visualization (see Fig. 3), these values can further be decomposed into damage categories: intact, light damage, medium damage, and heavy damage.

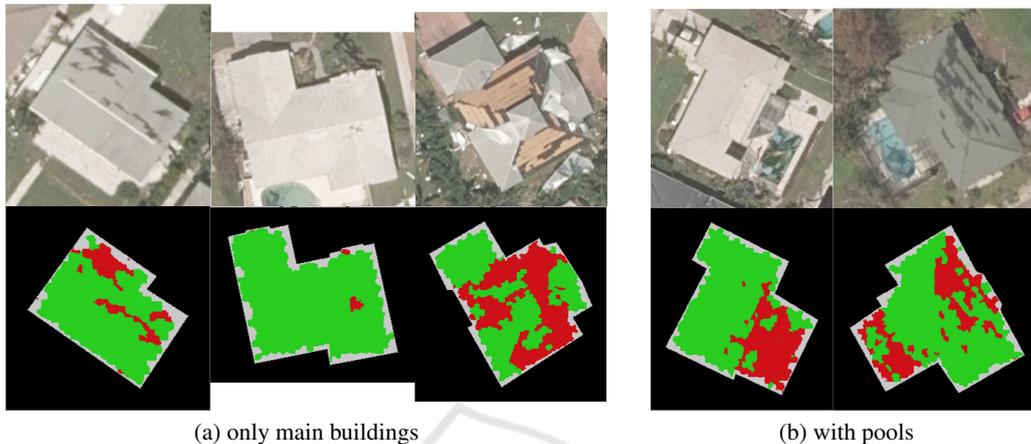
Figure 5: Damage location maps for several examples in D2.

The roofs in D2 are more diverse, featuring varied structures with different architectures and colors as well as elevated objects, than those in D1, which are generally homogeneous. In D2, the roofs are bordered by straight or curved lines and often include surfaces with many complex orientations. Due to this structural diversity, a larger amount of training data is required since distinguishing between roof structures and damage is more difficult. Examples of damage localized in D2 are shown in Fig. 5a. The three-fold cross-validation (see Tab. 1) revealed an overall testing accuracy of 91% although only 76% of all damaged roof patches that are present were recognized, which is approximately 10% less than that in D1. Here, only damage to the main roofs (no glass roofs) was considered. This lower recognition rate can be

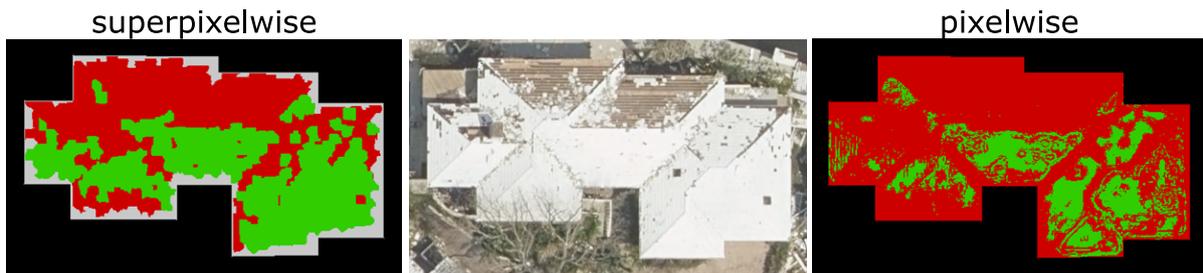
Figure 6: Comparison between superpixel-wise and pixel-wise evaluation often leads to a less precise result since information including neighborhoods and surroundings are omitted.

buildings in D1 required 12570000 pixels to be analyzed compared to 62600 superpixels. Thus, the number of superpixels was less than 1% of the number of pixels and greatly reduces the computational requirements. The evaluation of superpixels took only 6% of the computation time required to evaluate pixels but provided 10% better accuracy. One example of an imprecise pixel-wise result is shown in Fig. 6. While it was initially hypothesized that a pixel-wise localization would be more effective, the lower accuracy achieved in the pixel-wise evaluation can be attributed to the loss of context and neighborhood information using a pixel-wise approach.
